Evaluation Report

Melroe Model 103 Spracoupe

Melroe Model 103 Spra-Coupe

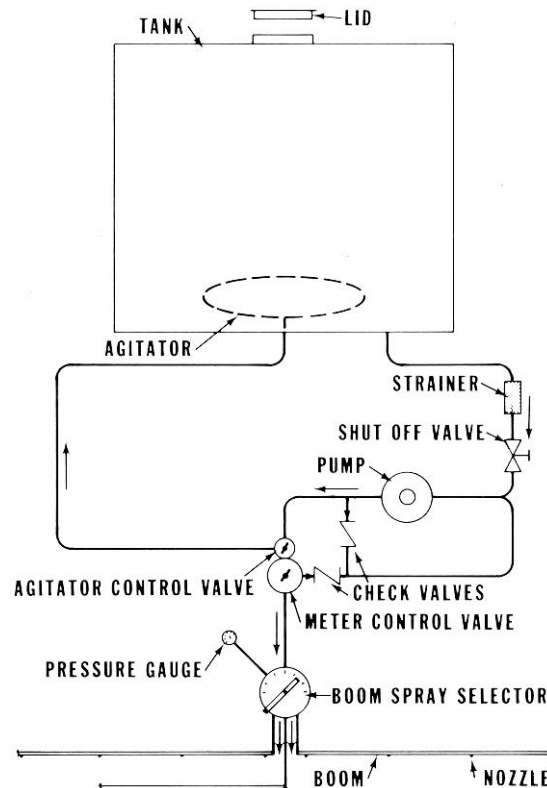
Figure 1. Flow Diagram for Melroe Spra-Coupe Model 103.

Figure 1 shows the flow diagram for the Spra-Coupe while complete specifications are found in Appendix I.

valves (Figure 1). This did not affect the calibration of the Spra-Coupe but it reduced pump output.

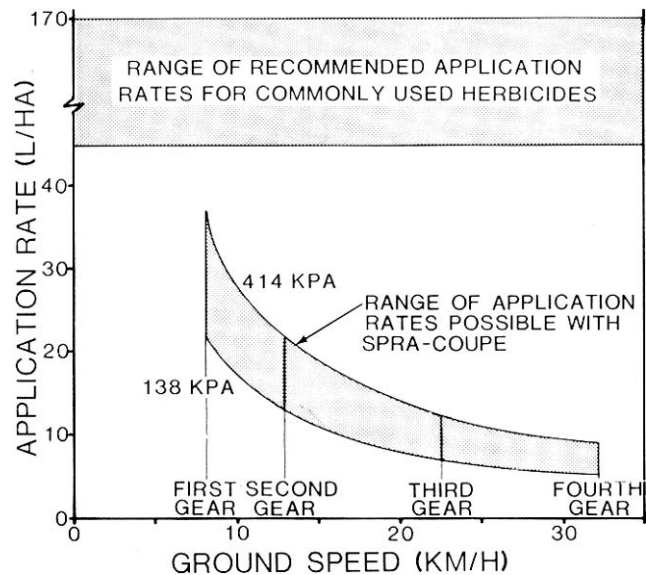
Application Rates: Figure 6 shows the range of application rates that were possible using the Delavan LF 77-730 nozzles, supplied with the Spra-Coupe, over a pressure range from 138 to 414 kPa (20 to 60 psi). It also shows the normally recommended range of water application rates for commonly used herbicides on the prairies. Delivery from the nozzles was too low to apply sufficient water in all cases. The maximum application rate was 37 L/ha (3.3 gal/ac) in first gear with lower rates at higher operating speeds. The range of application rates recommended for most herbicides used on the prairies is 45 to 170 L/ha (4 to 15 gal/ac). It is recommended that the manufacturer supply higher capacity nozzles as standard equipment so that application rates are within the recommended range. The higher capacity nozzles would have the added advantage of less spray drift since droplet size would be larger.

Figure 6. Application Rates for the Spra-Coupe using Delavan LF 77-730 Nozzles.

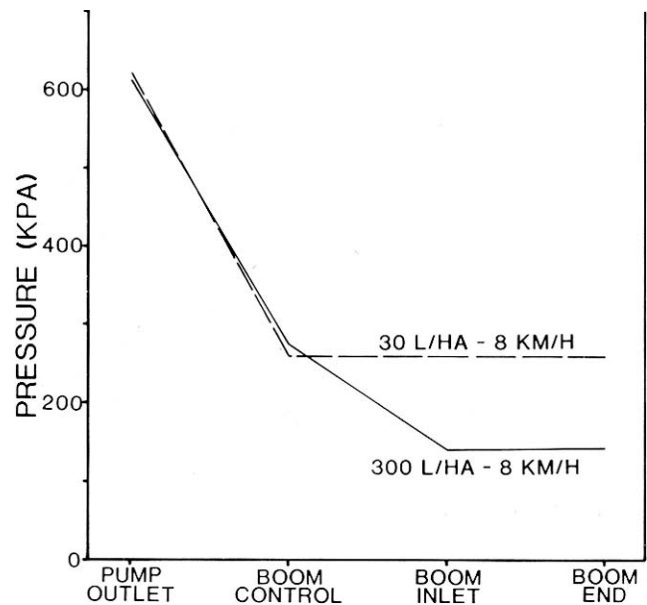
Figure 12 shows the pressures at the various locations when applying 30 to 300 L/ha (2.7 and 26.7 gal/ac) at 8 km/h (5 mph) at a boom control valve pressure of 275 kPa (40 psi). The pressure at the pump outlet was 620 kPa (90 psi). The high pressure at the pump outlet occurred at all pressure settings and with different nozzle sizes. High pump pressure was due to flow restrictions caused by the agitator and meter

With 30 L/ha (2.7 gal/ac) low capacity nozzles, pressure losses from the boom control valve to the booms were small. With 300 L/ha (26.7 gal/ac) high capacity nozzles, pressure losses from the control valve to the boom were up to 170 kPa (25 psi) which affected calibration and nozzle distribution patterns. In addition, there was a 41 kPa (6 psi) pressure drop across the nozzle check valves.

Figure 12. Pressure Losses through the Plumbing System Applying 300 and 30 L/ha (26.7 and 2.7 gal/ac) in First Gear.

Pressure drops from one end of the boom to the other were negligible with all sizes of nozzles (Figure 12), indicating adequate boom size.

distribution patterns, pressures at the boom control should be set higher by amounts indicated on Figure 12. Modifications are required so that actual pressure is known.

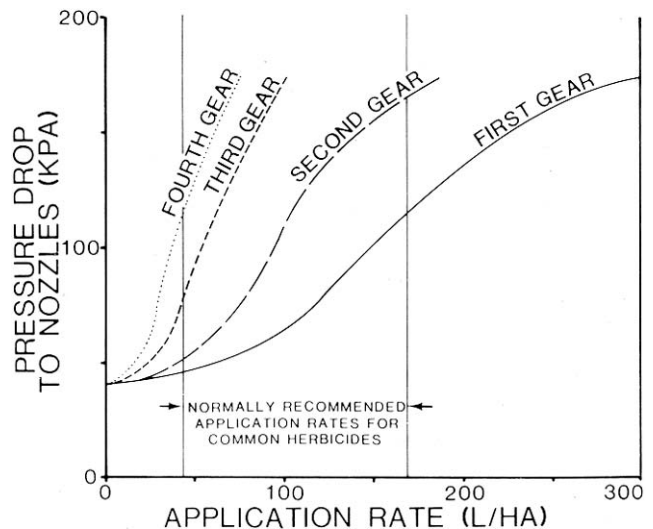
Figure 13 shows the pressure losses from the control valve gauge to the nozzles at various application rates in each gear. For example, application at 100 L/ha (8.9 gal/ac) in third, second and first gears resulted in corresponding pressure losses of 170, 105 and 65 kPa (25, 15 and 9 psi) from the control valve to the nozzles. At lower application rates such as 50 L/ha (4.5 gal/ac) the pressure losses were 95, 54 and 45 kPa (14, 8 and 7 psi). For accurate calibration and proper

Figure 13. Pressure Losses from the Control Valve to the Nozzles at Various Application Rates and Operating Speeds.

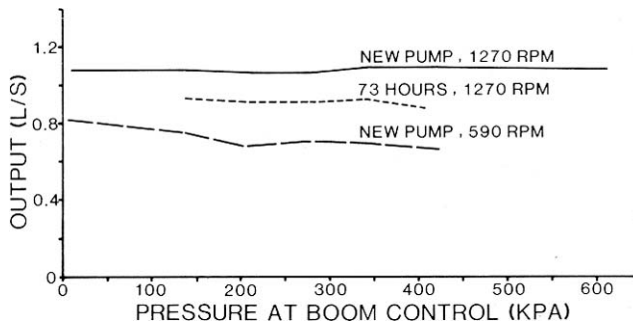
Operation at Reduced Speed: Figure 14 shows that reducing pump speed from 1270 rpm (full engine throttle) to 590 rpm (half throttle) resulted in a 36% reduction in pump capacity. Reduction in pump speed could occur when reducing speed to turn a corner or when operating at reduced engine speed to obtain a correct ground speed to suit nozzle calibration.

Pump Wear: Pump capacity decreased by 17% after the 73 hours of field operation. Pump wear depends on the type of chemicals sprayed and abrasive materials in the water.

Figure 14. Pump Curves.

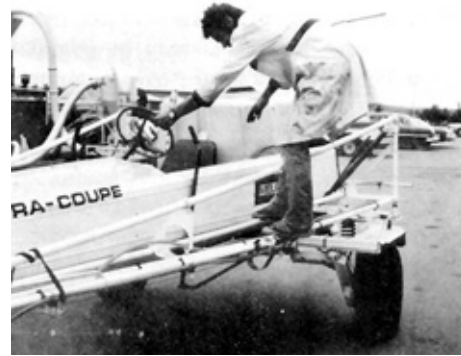
Figure 16. Awkward Mounting in Transport.
